MEMOIRS OF THE
ARCHAEOLOGICAL SURVEY OF INDIA
NO. 91

ANGKOR VAT

INDIA'S CONTRIBUTION IN CONSERVATION

1986-1993

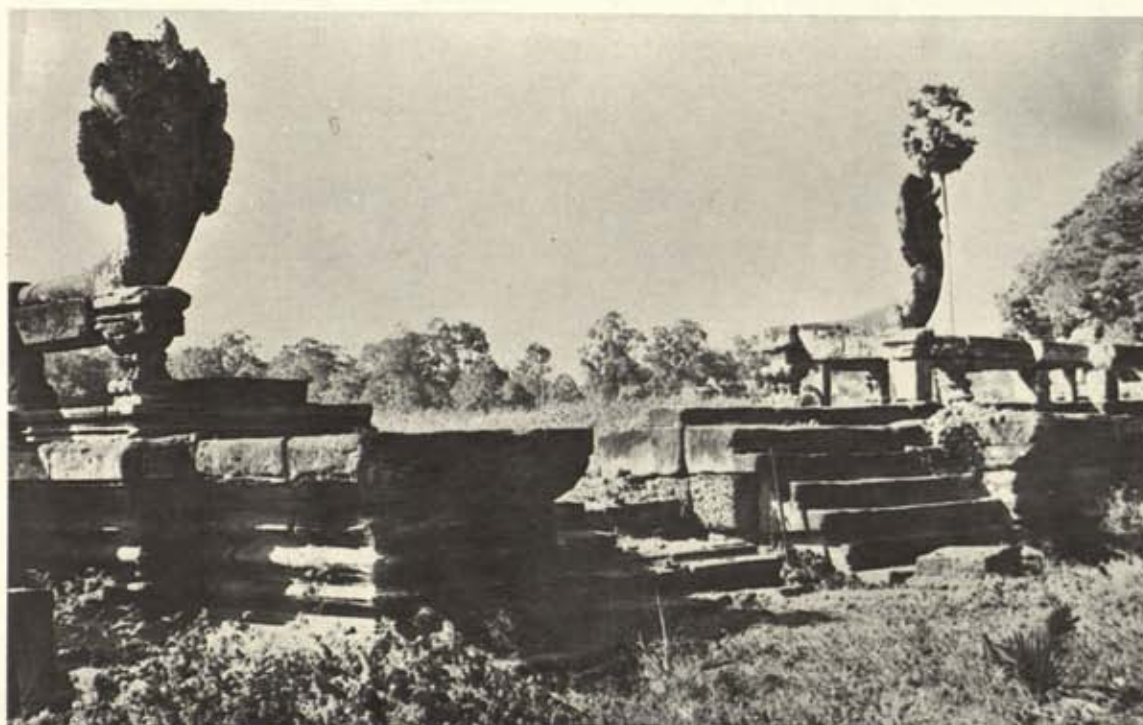
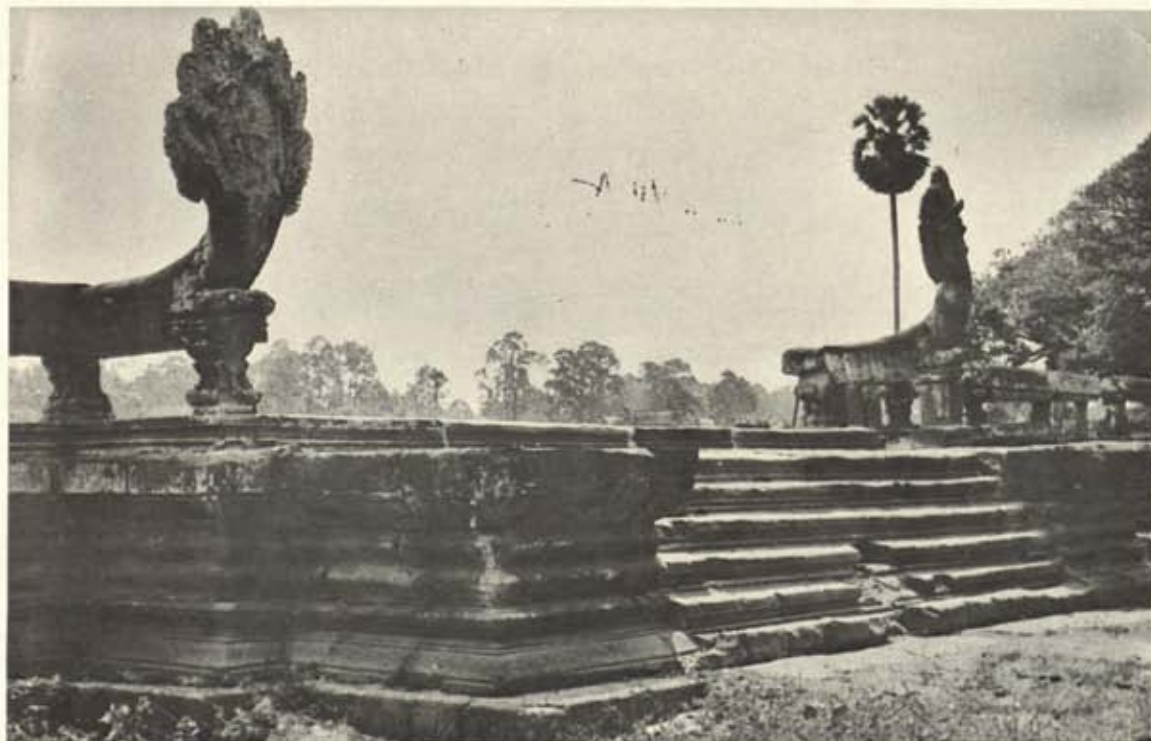
A
B
First Enclosure : south-west corner tower, A, before and B, after conservation

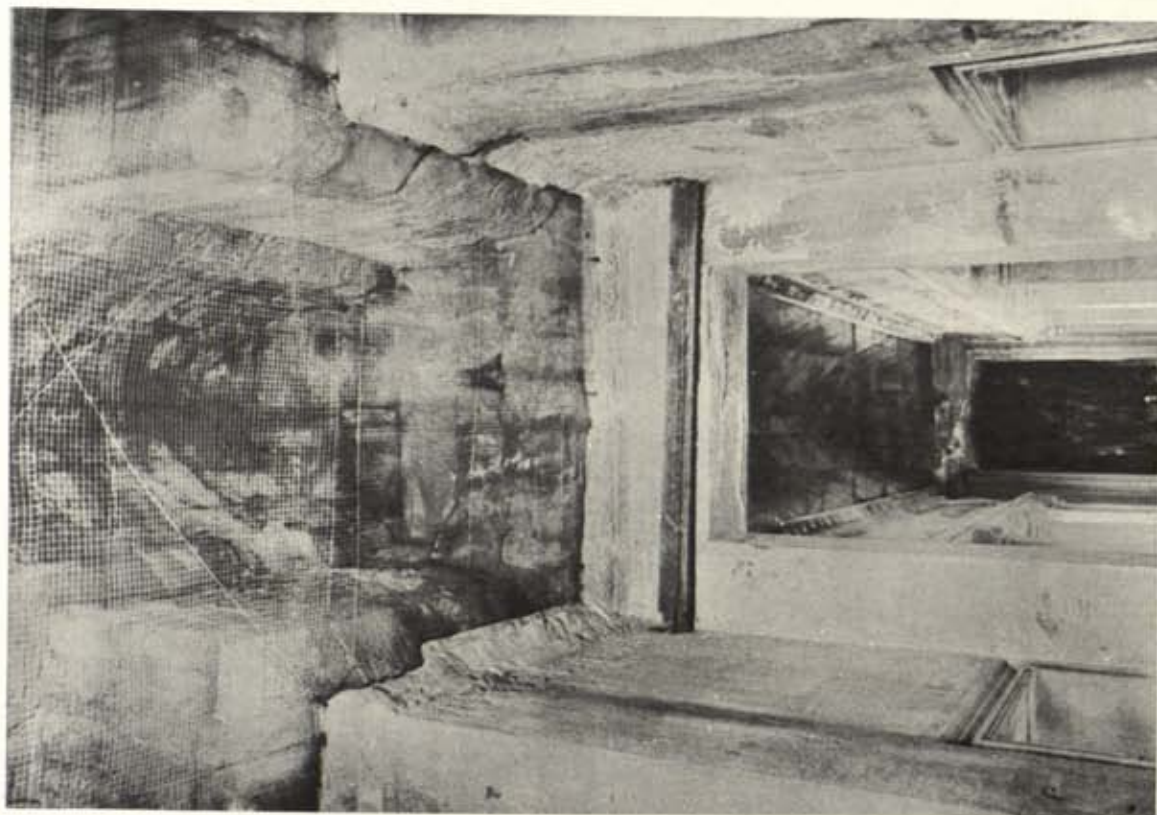
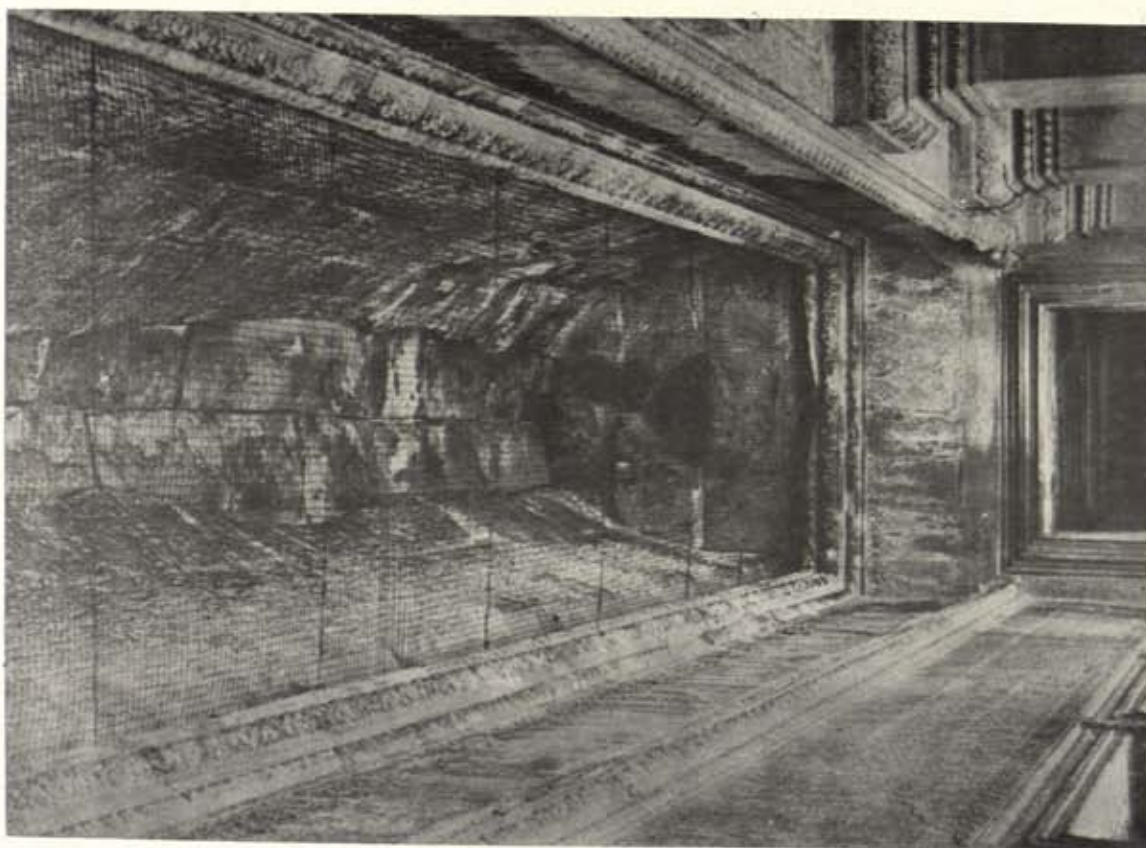
Railing between Third and Fourth Enclosures : stepped entrance at north-west corner, A, before and B, after conservation

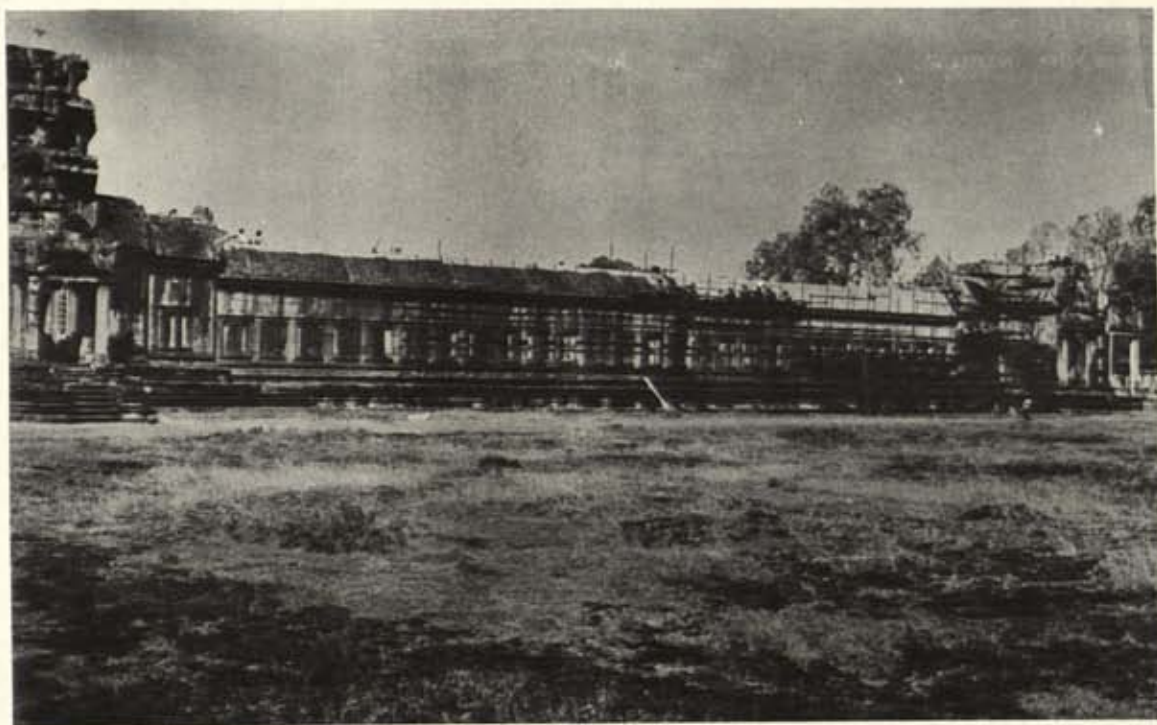
First Enclosure : galleries provided with welded mesh

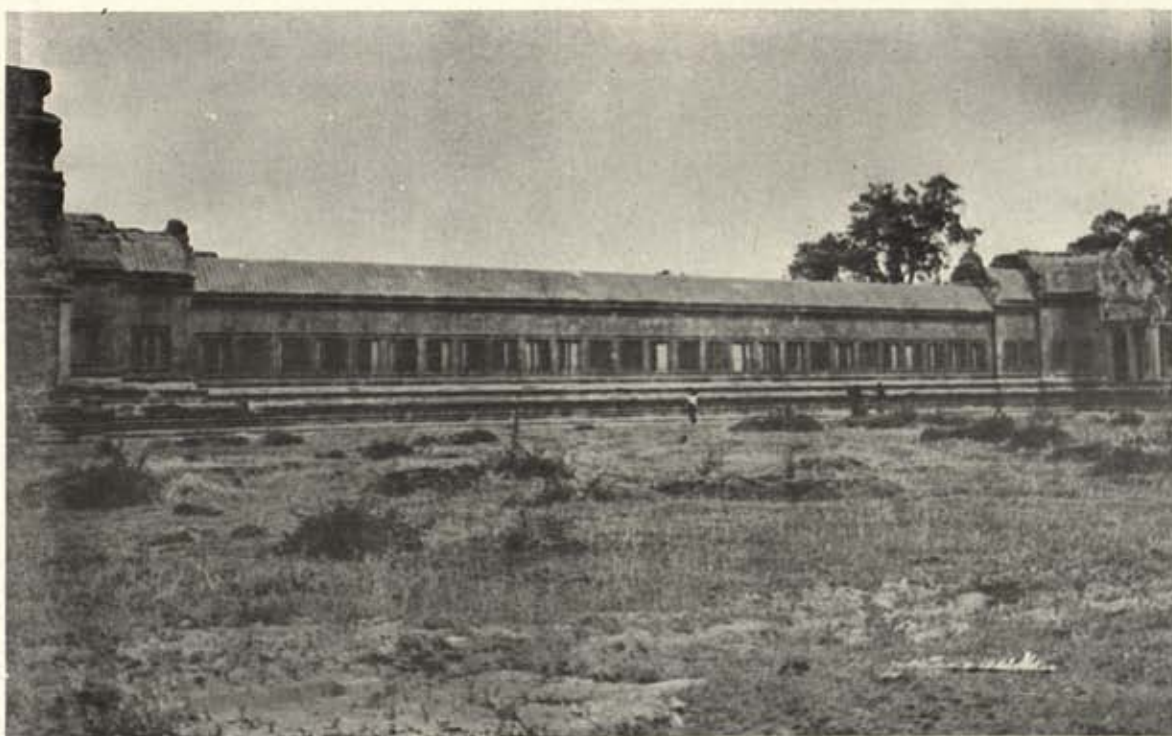
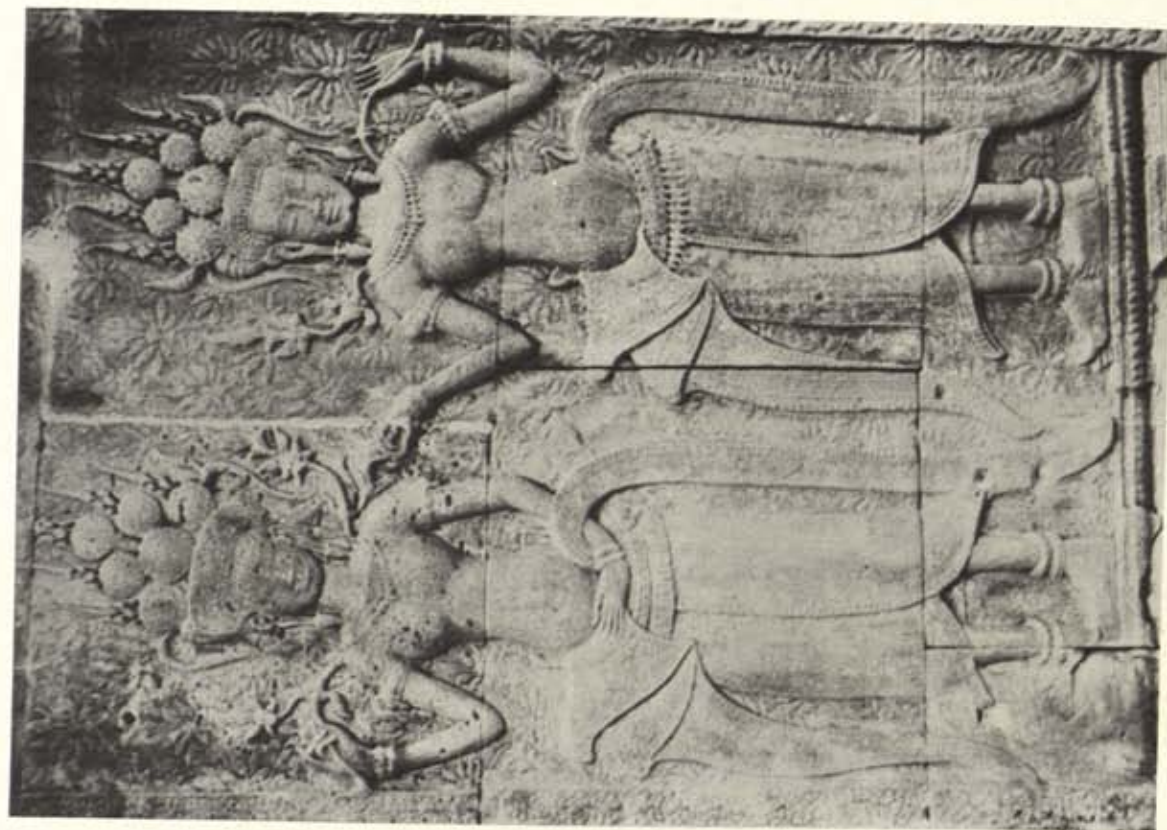
CHEMICAL DECAY—It is a well established fact that the ancient monuments in the tropical region are affected by micro-vegetational growth. The Angkor Vat is no exception. In fact the entire exterior surface of the temple complex was covered with thick growth of a variety of cryptogamous organisms such as moss, lichens, algae and fungi. In addition, in the interior where there was seepage of rain water there were patches of dark and greenish moss.

Fourth Enclosure: Western Gateway, A, before and B, after chemical treatment

instance, the surface was moistened with water by spraying. Then the area was cleaned with 1 to 2 percent solution of liquid ammonia, used only to neutralize acids secreted by the hyphae of the micro-vegetation, mixed with teepol, a non-ionic detergent, and by brushing gently with nylon brushes or tooth brushes or soft coir brushes, as the situation demanded. The surface was therefore cleaned thoroughly with water. The area thus cleansed was treated with 2 percent solution of polycide, biocide and zinc silico fluoride separately. Finally, after complete drying of the area, it was preserved by applying a coat of 2 percent of polymethyl methacrylate in toluene.

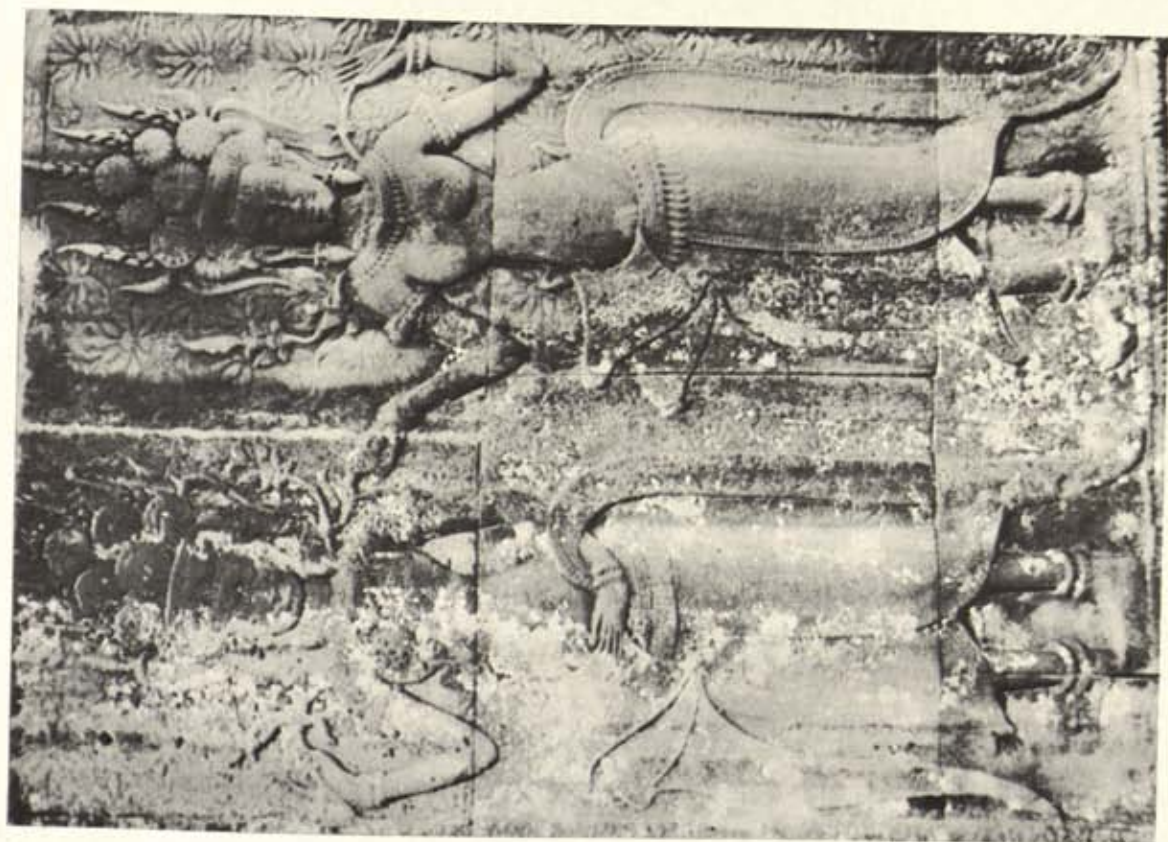
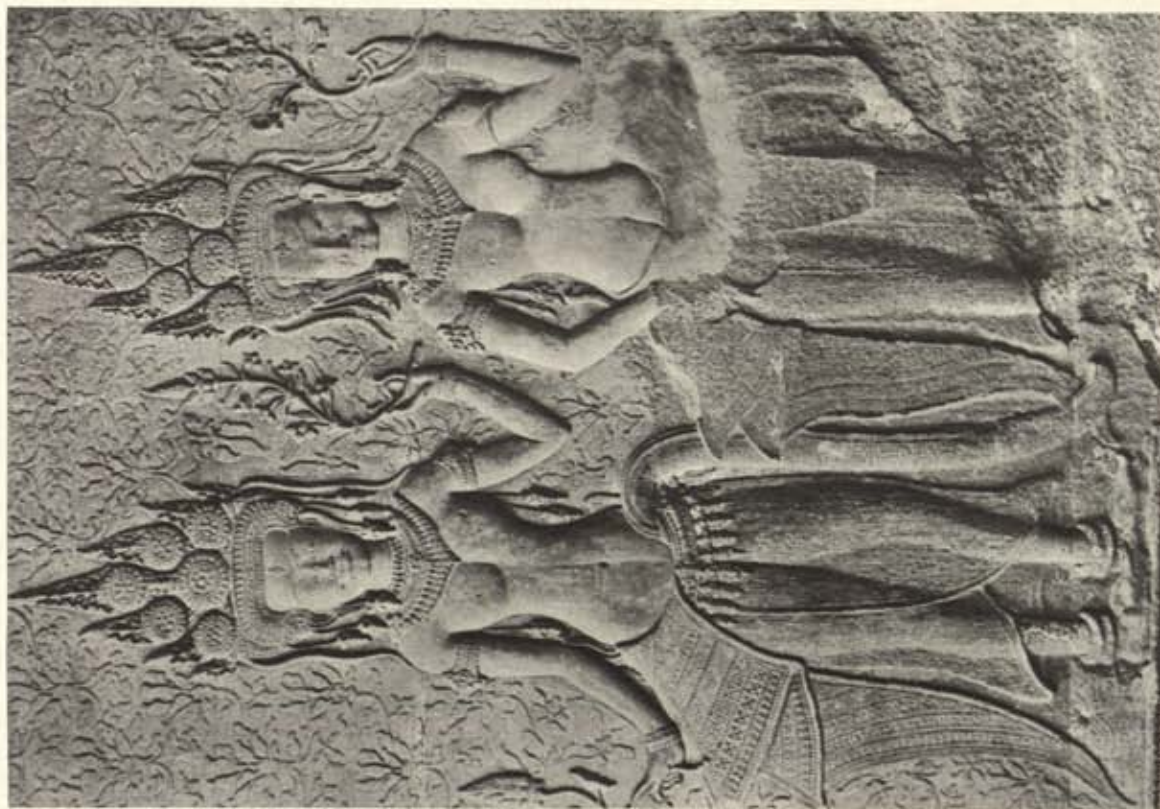
Fourth Enclosure : Western Gateway, apsaras, A, before and B, after chemical treatment

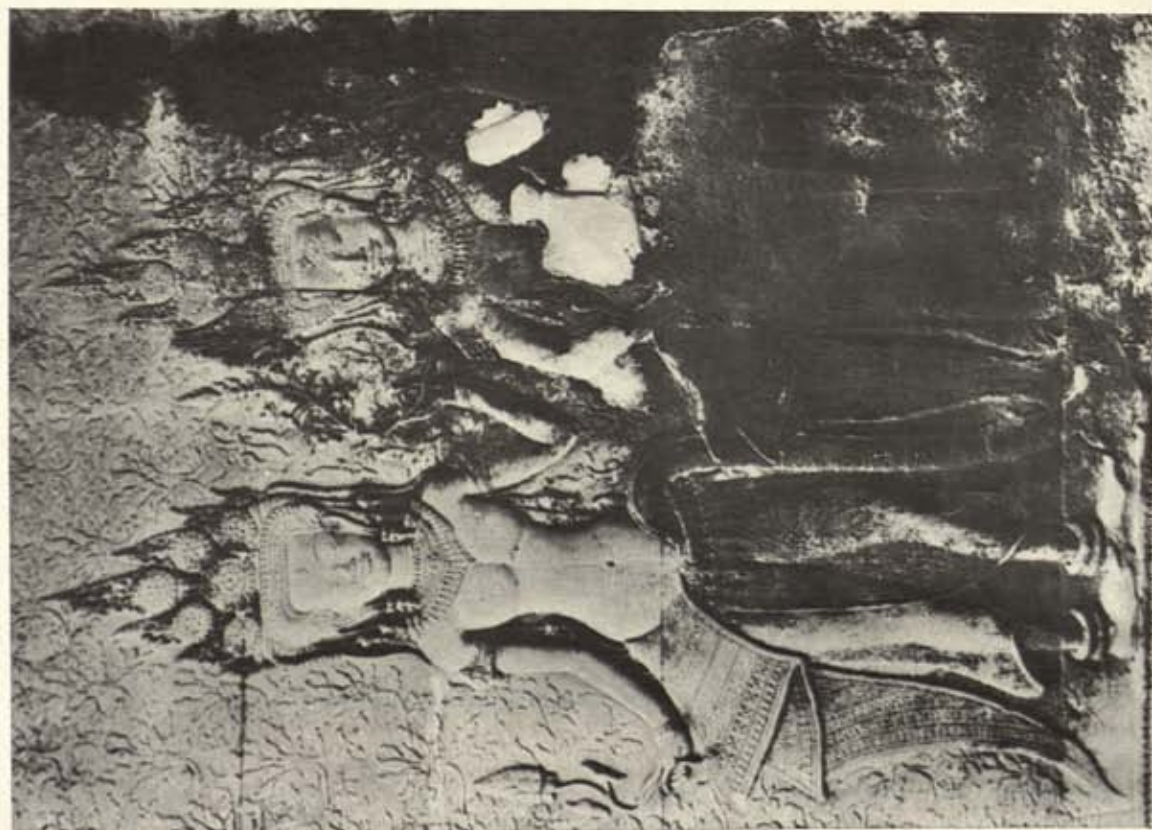
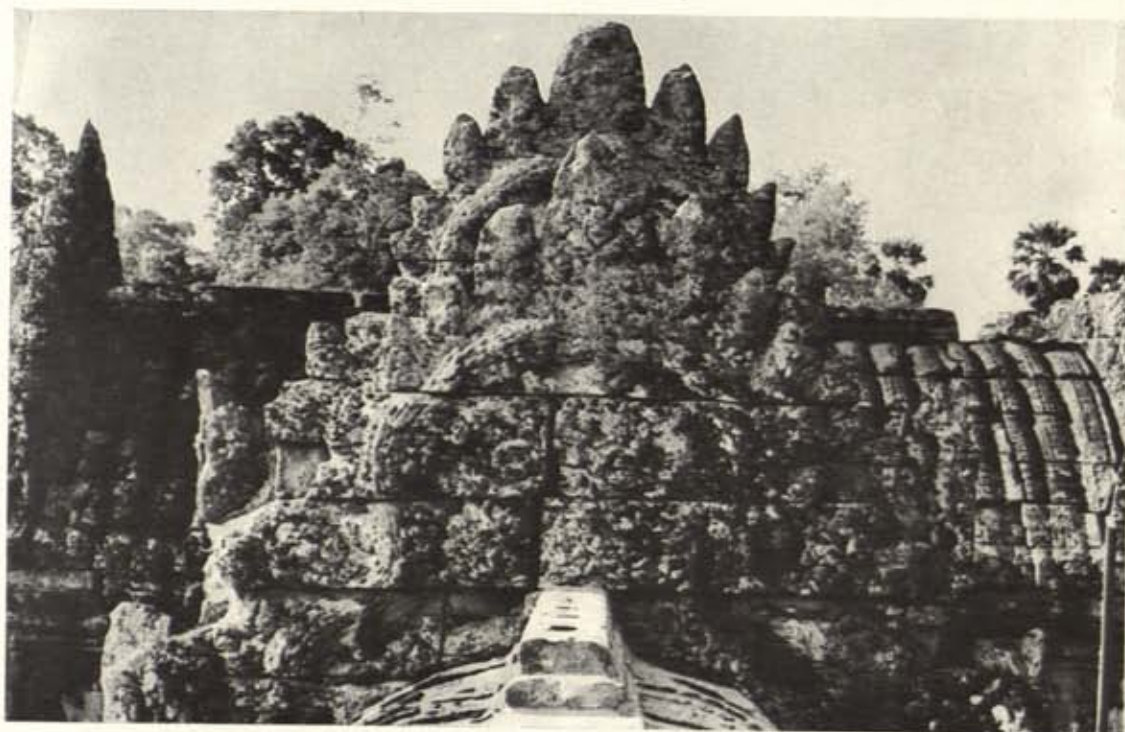
Fourth Enclosure : Western Gateway, apsaras, A, before and B, after chemical treatment

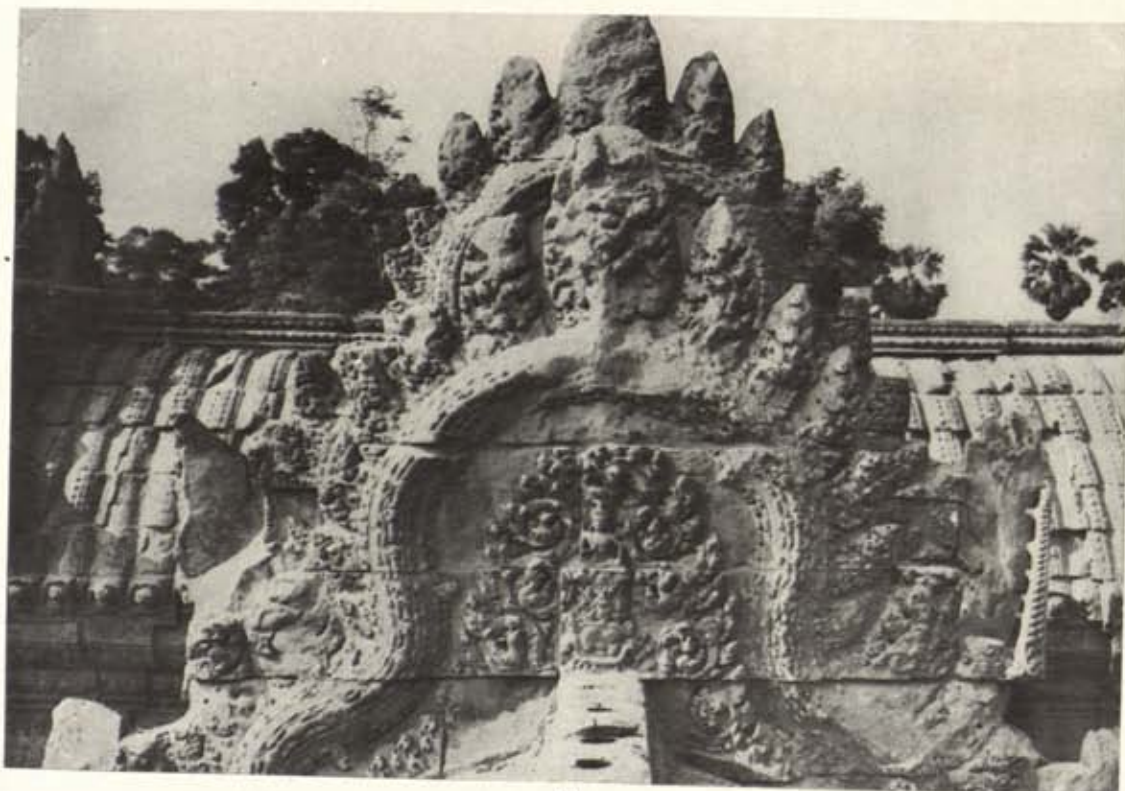
Fourth Enclosure : Western Gateway, a torana on the roof, A, before and B, after conservation and chemical treatment

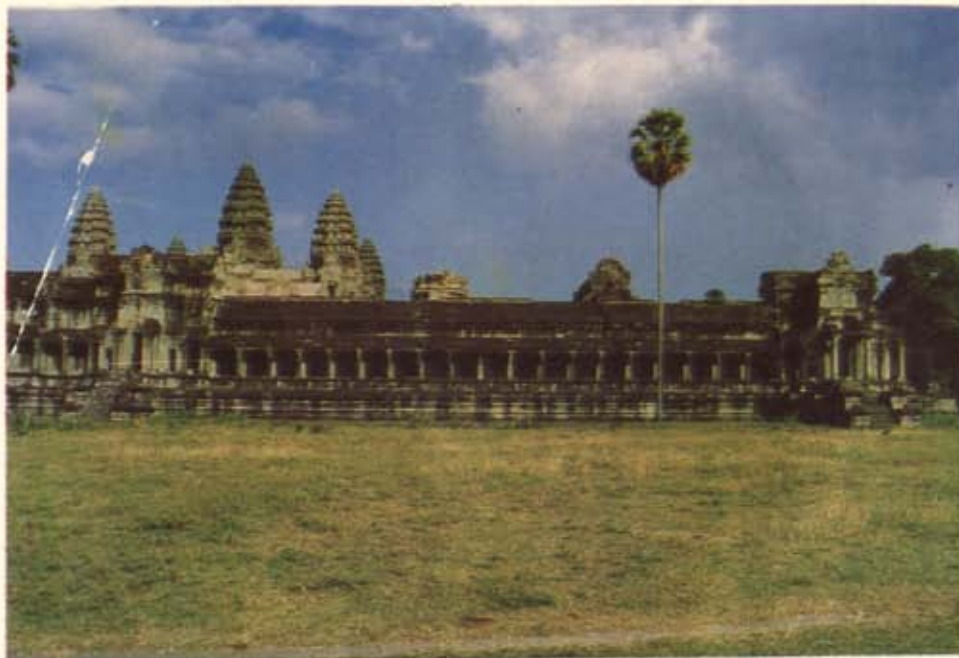
A

Third and First Enclosures : towers and enclosures, A, before and B, after chemical treatment

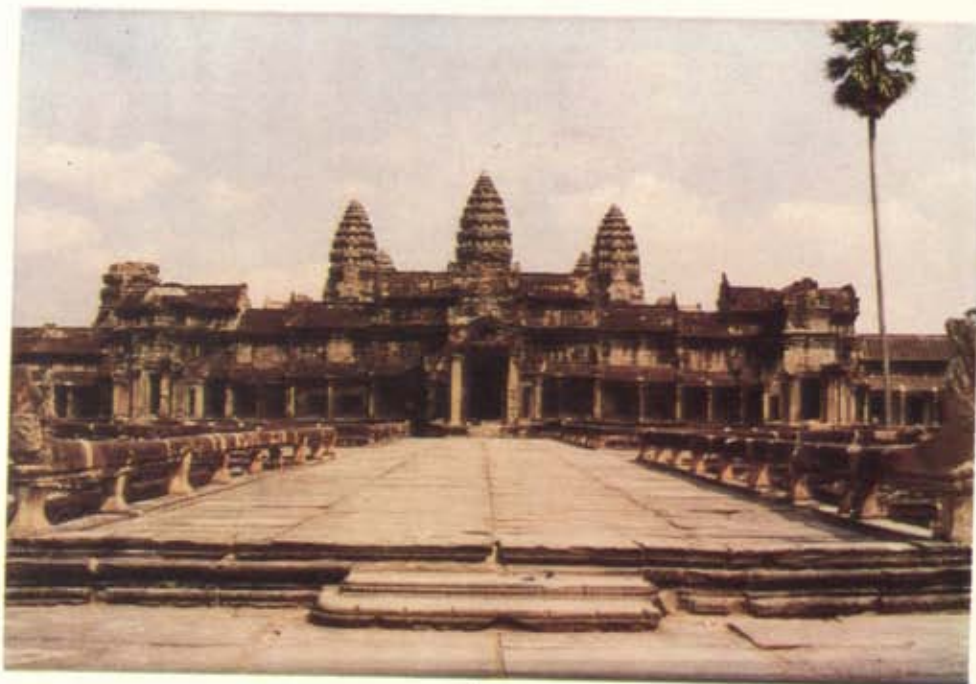
A

Esplanade and Third and First Enclosures, A, before and B, after chemical treatment

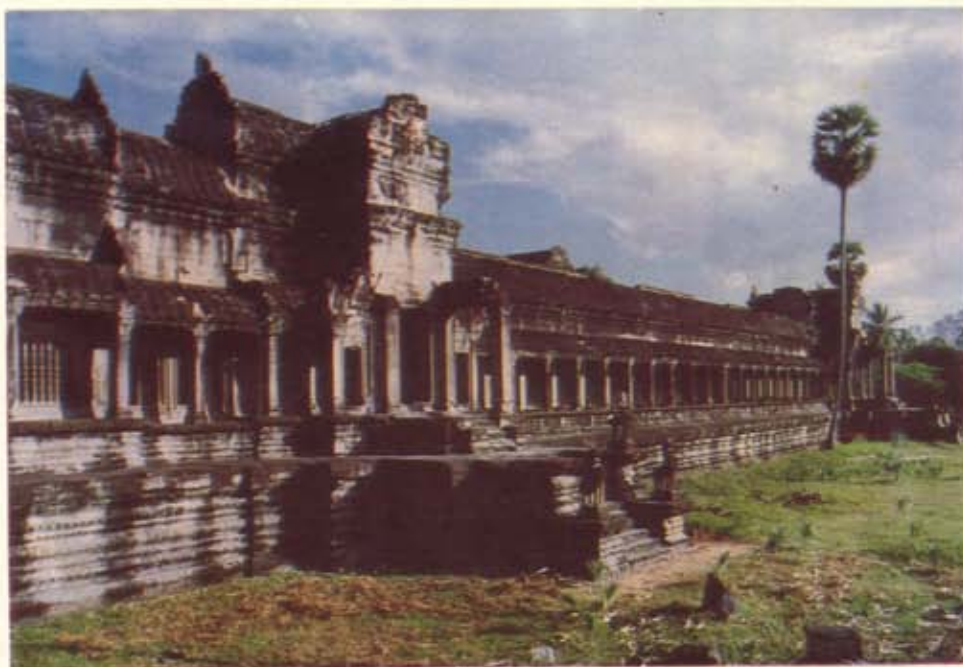
A

Third Enclosure : Southern Gallery on western side, A, before and B, after chemical treatment

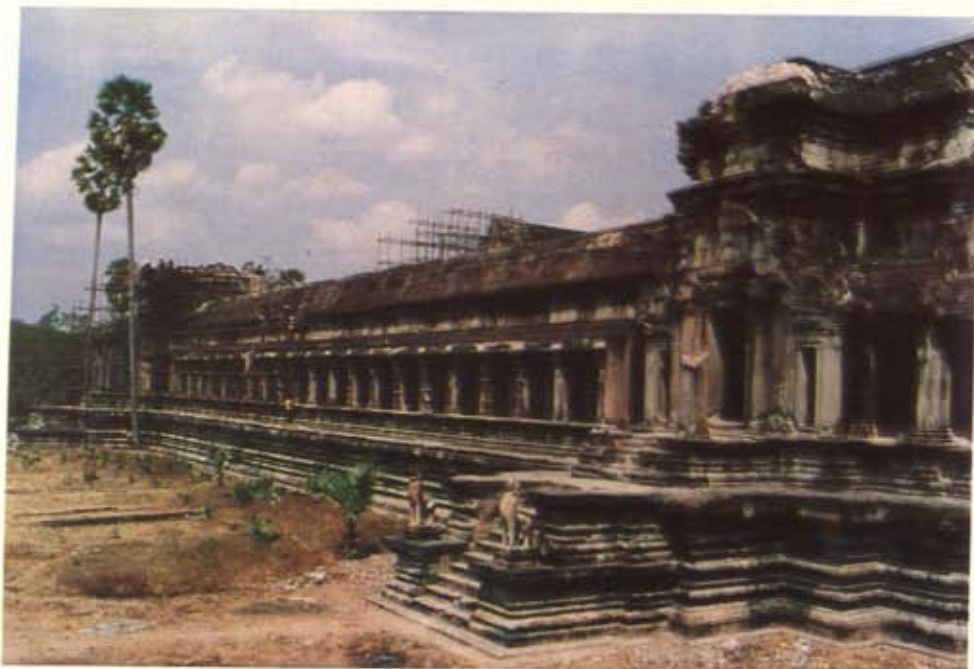
A

Third Enclosure : Northern Gallery on western side, A, before and B, after conservation and chemical treatment

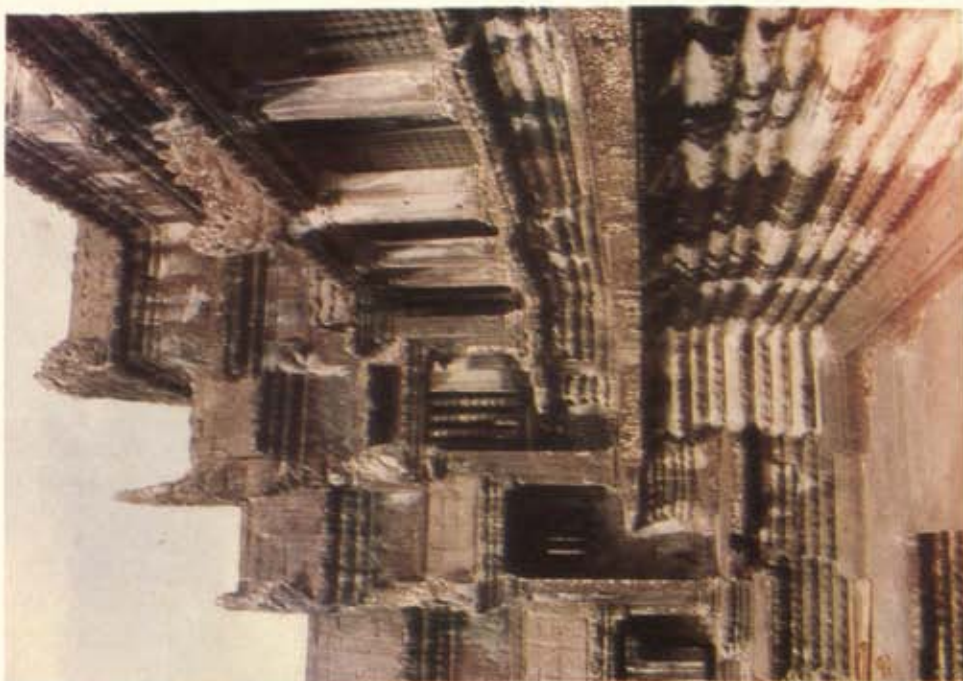
A

Antechamber : galleries, A, before and B, after chemical treatment

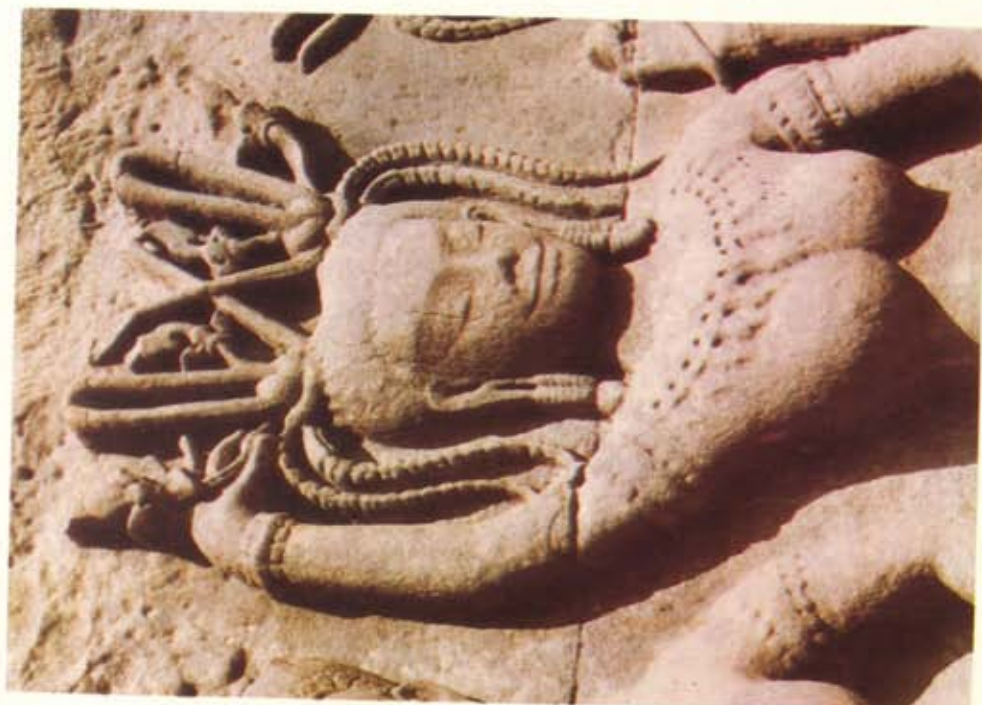
B

Second Enclosure : apsara, A, before and B, after chemical treatment

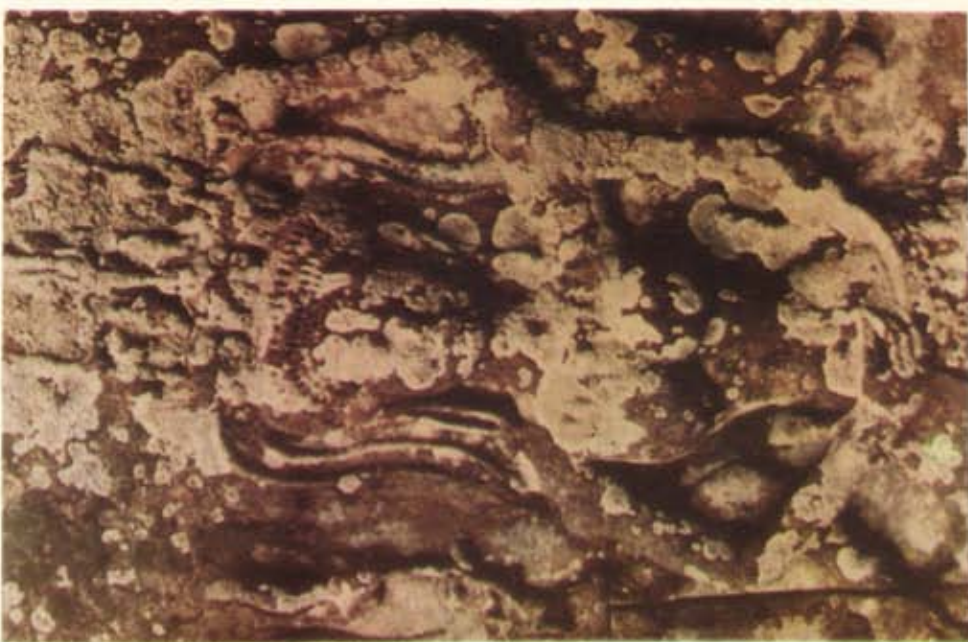
A

Second Enclosure : apsara, A, before and B, after chemical treatment

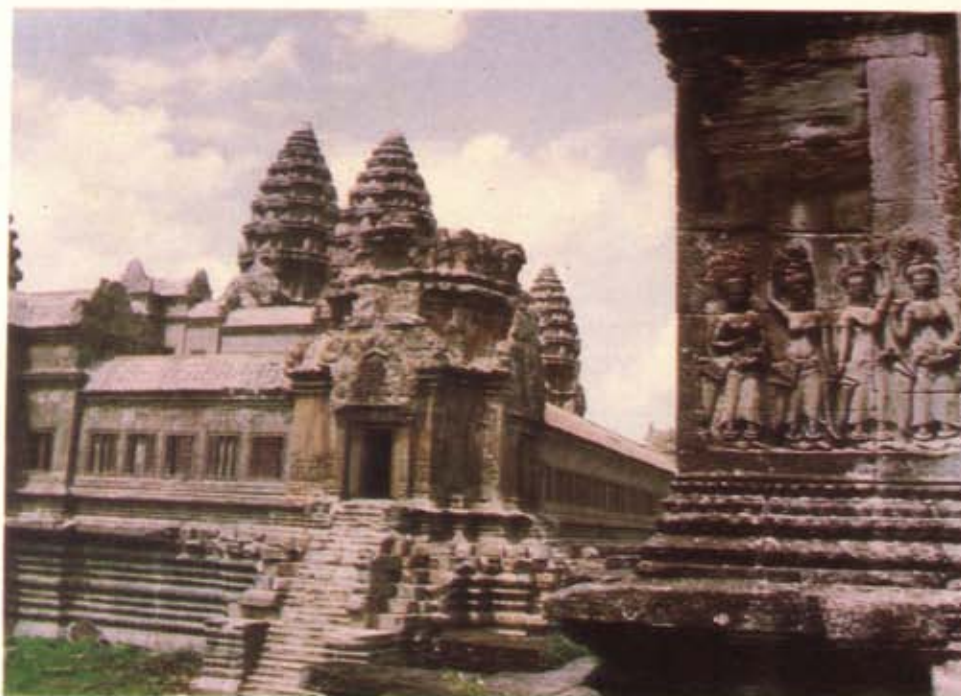
A

Library between Second and Third Enclosures : apsaras, A, before and B, after chemical treatment
